# Investigation of the earthquake behavior of historical erzincan çadırcı bath and the reasons for its persistence until today

# Investigation of the Earthquake Behavior of Historical Erzincan Çadırcı Bath and the Reasons for Its Persistence Until Today

*Araştırma Makalesi / Research Article*

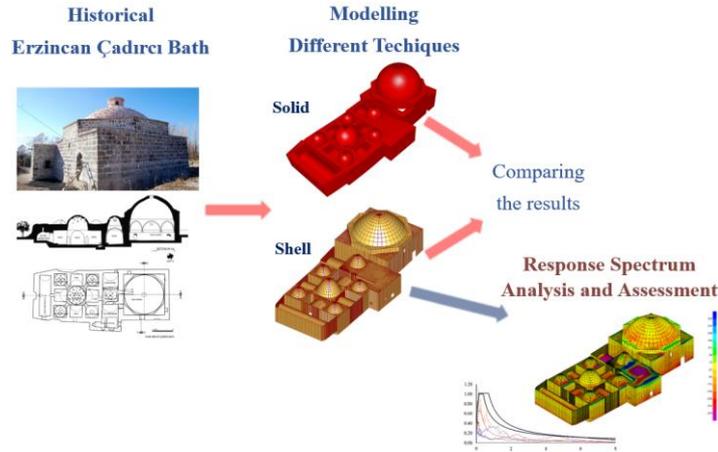
The historical bath was modelled in two different types according to shell and solid modelling techniques. Response spectrum analysis was performed, and structural elements were evaluated.

Figure. Graphical abstract

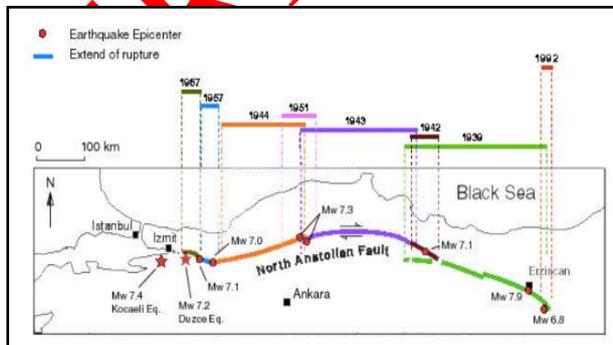
Figure 1. Successive earthquake sequence on the North Anatolian Fault since 1939 [22]

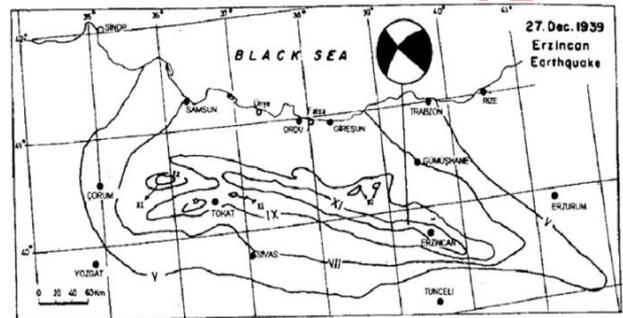
Figure 2. 1939 Erzincan earthquake surface rupture and Mercalli earthquake intensity map [27]

on 27 December 1939 shattered approximately 49 km of the surface [23]. 1939 Erzincan earthquake as shown in Figure 2, with a moment magnitude of 7.8 Mw and maximum Mercalli intensity of XII, is the second strongest earthquake recorded in Turkey after the 1668 North Anatolian earthquake [24]. In addition, it is one of the largest in a sequence of violent shocks to affect Turkey between 1939 and 1999 along the North Anatolian fault [25]. While approximately 33,000 died in the earthquake, 100,000 people were injured [26]. Due to the collapse of most of the buildings, due to the earthquake, the Erzincan urban settlement was abandoned and rebuilt in a different area.

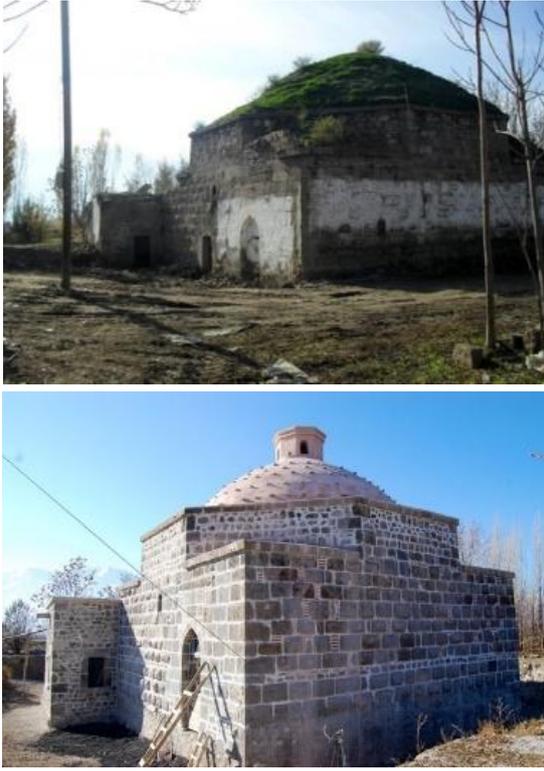
**Figure 3.** Çadırçı Bath before and after restoration (2016-2020) (from the the Author's archives)

The Historical Çadırcı bath, the research object, is located in the old city settlement, which was relocated after the 1939 earthquake in the south of the Erzincan modern urban settlement. According to the construction and repair inscriptions on the building, the Çadırcı bath was built in 1548 by the son of Mahmut, Şeyh Ahmet, and it was repaired between 1677-78 [29]. It is one of the three bath structures that have survived the old city, which was destroyed by the 1939 earthquake. There was no structural damage in the Çadırcı bath in the 1992 earthquake either. The building, which continued to function as a bath until the 1950s, remained unused for many years [30]. It was declared a monument by the Turkish Ministry of Culture in 1980 and restored between 2016 and 2020 (Figure 3).

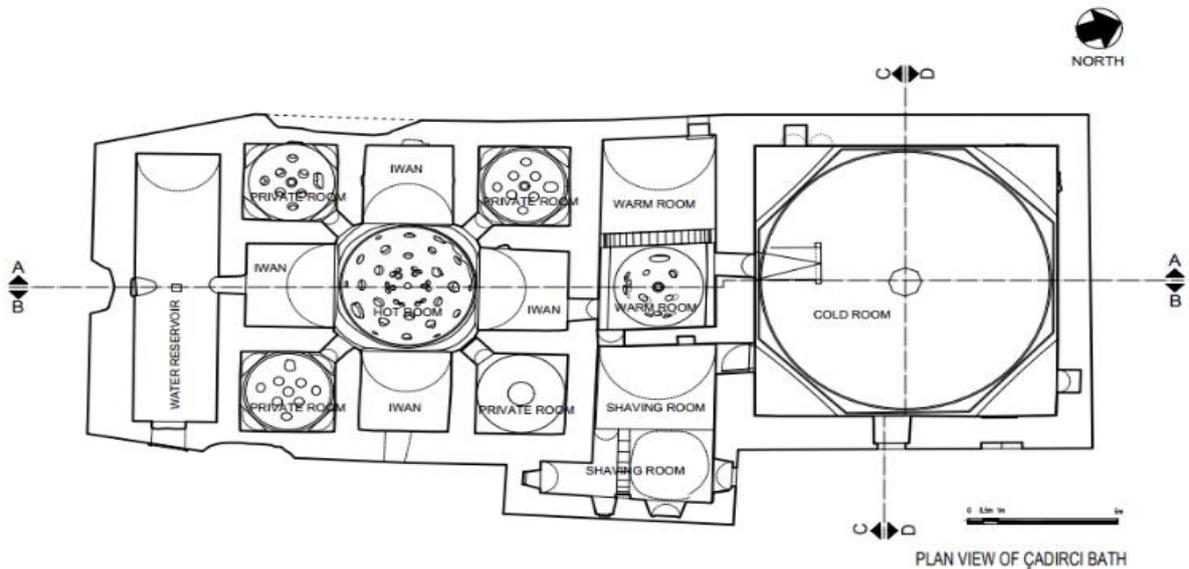
**Figure 4.** Plan view of Çadırçı Bath

shaving room, a hot room, a water tank, and a stove from north to south (Figure 4).

The first room of the bath is a square planned cold room with 10.10x10.10 m interior dimensions (Figure 4). This area is covered with a dome resting on an octagonal drum. The dome, which is 19 m in diameter and 3.7 m high, is supported by eight pointed arches resting on eight buttresses inside. At the top of the dome, there is a lantern for illumination. There are two windows on this area's western and northern outer walls. The next area is the warm room measuring 3.76 x 7.60 meters (Figure 4). The warm room is divided into two by an arch and is covered with a vault and a dome (Figure 5, Section A-A). There are 12 light holes (oculus) made of terracotta pipes on the dome for lighting. In addition, from the eastern wall of the warm room, it is passed to the section called the shaving cell. The L-shaped shaving area is the only room that protrudes from the plan view on the east side of the building. This place is also covered with arches and vaults, with windows on the north and east walls. The main bathing area of the bath is the hot room. This place has a square plan with internal dimensions of approximately 10.90 x 10.90 m. The space consists of four iwans (even) placed axially around the center and private cells (halvet) at the corners. A large dome covers the central area. While private cells are covered with a smaller and flat dome compared to the central dome, the iwans are covered with barrel vaults. The middle dome has forty-two light holes (oculus) and ten eyes in the other three smaller domes. The last room is the water reservoir, with a fireplace underneath. This area has internal dimensions of 2.80 x 10.00 m and is covered with a barrel vault. There is also a chimney in the middle of the room. This section, whose walls were destroyed, is the most devastating part of the bath. Although there are plaster traces on the bath walls, it was thought that these are not original [31].

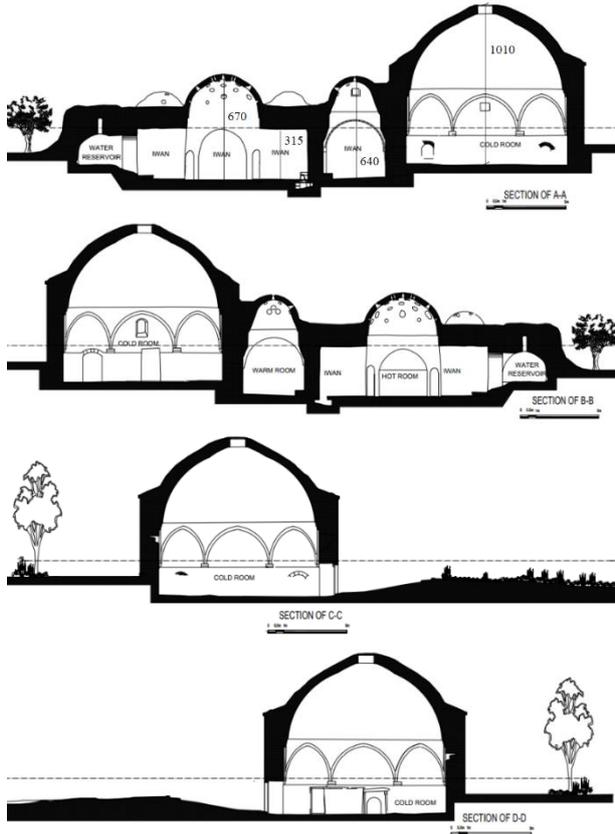
Figure 5. Section views of Çadırcı Bath (The units of heights are cm.)

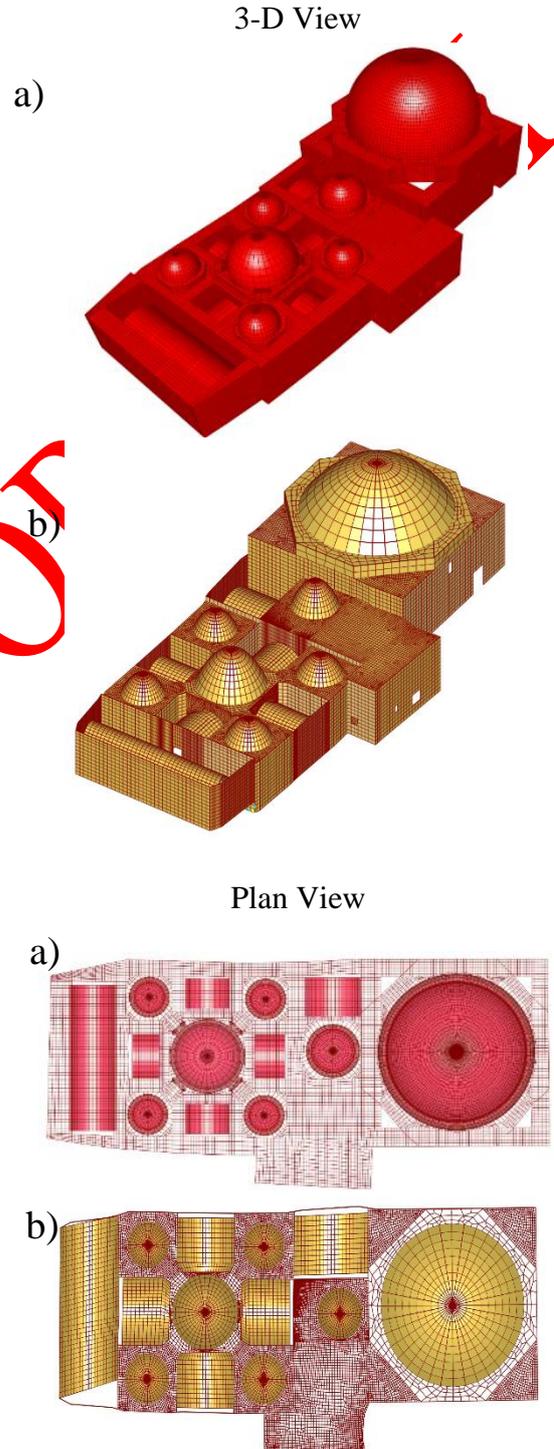
Figure 6. a) Solid model b) Shell model

To assess the structural behavior of the historical Çadırcı bath under earthquake loads, both the solid model and the shell model of the structure were created in SAP2000 V24 software [21]. Two different modeling types, solid and shell, were used in this study to compare modeling processes, analysis times, and analysis results, and to verify the finite element models created with the macro modeling technique. In the macro modeling technique, the masonry units forming the wall and the mortar connecting the masonry units are reduced to a single homogeneous material and modeled. In the solid model, all the walls, vaults, and domes in the historical building are modeled as solid elements, while the arches carrying the main dome are modeled as frame elements. There are 109,497 solid elements and 78 rigid frame elements in the solid model. Eight-node objects were used to meshing in solid model. Each object has six quadrilateral faces with a joint at each corner.

All elements are modeled with 16 different types of shell elements defined to be suitable for their thickness in the shell model. Four-node Quadrilateral Elements were used for meshing in shell model. The Shell elements activates all six de degrees of freedom at each of its connected joints. Eight arches carrying the main dome in the building are modeled as curved frame elements in a 30x30 cm section. In addition, rigid frame elements are used to provide load transfer from the vaults to the walls. The shell model has a total of 30,319 shell elements and

203 frame elements. In both models, the soil-structure interaction is not considered and fixed supports were used. The total weight of the structure was calculated as 2084 tons in the solid model and 2187 tons in the shell model. The solid model was analyzed in 11 minutes and the Shell model in 4 minutes on a 32 Gb Ram 16 core processor computer. The finite element models created are shown in Figure 6.

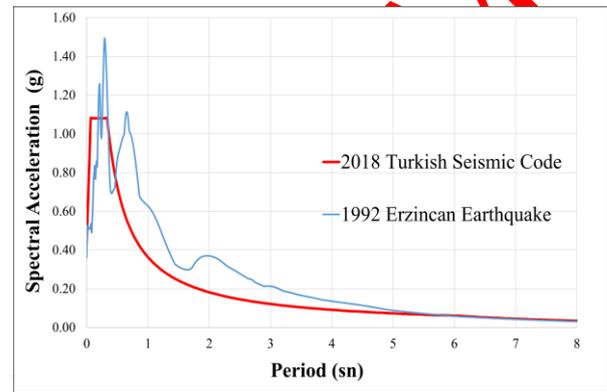
**Figure 7.** Response spectrum

To assessment the earthquake behavior of the Historical Çadırcı Bath, Response Spectrum analysis was performed according to the Turkish Seismic Code [33]. In the analysis, the earthquake level was determined as a designed earthquake with a probability of exceeding 10% in 50 years (recurrence period of 475 years). As seen in Table 2, local acceleration values of the location of the historical building were taken from AFAD's interactive earthquake risk map [34].

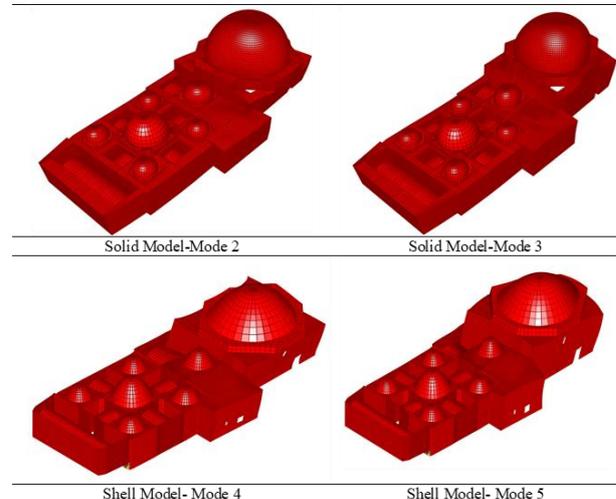
**Figure 8.** Dominant mode shapes

In this study, the results of the analysis for the historical Çadırcı bath were examined based on 3 main building elements. These structural elements are domes, vaults, and walls. First of all, modal analysis was carried out, and the dominant mode shapes and periods of the historical Çadırcı bath were obtained separately for the solid and shell models, as seen in Figure 8 and Table 3. In both models, the Y direction translation and torsion mode are obtained in the same mode. The periods calculated in the Solid and Shell models are within the expected limits.

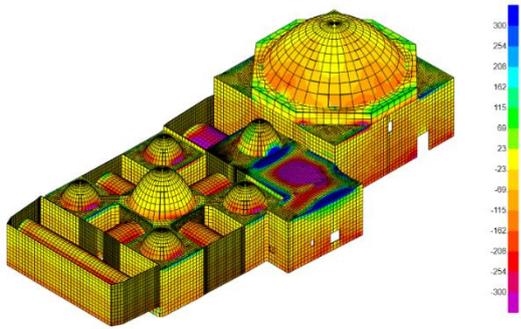
**Figure 9.** Vertical stresses under G+Q combination

Considering the filling material on the vaults and floors in the historical building, a filling load (G) of 3 tons/m<sup>2</sup> on the vaults and 1.5 tons/m<sup>2</sup> on the floors has been defined. In addition, a live load (Q) of 150 kgf/m<sup>2</sup> is defined in the model. As seen in Figure 9, in the static analysis of the structure under its weight, it was observed that none of the elements exceeded the compressive strengths given in Table 1.

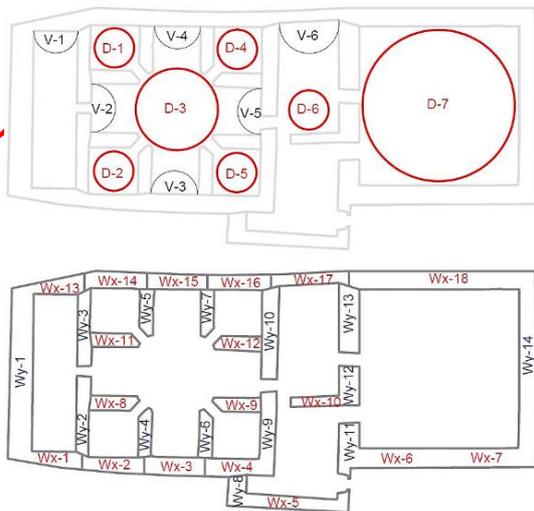
**Figure 10.** Labels of structural elements

According to the Turkish Seismic Code (TSC), response spectrum analysis was performed in X and Y directions for the historical Çadırcı bath. The complete quadratic coupling (CQC) method was used as the mode coupling method. The damping rate in the analysis is 5%. To evaluate the results more accurately, each building element was named separately as seen in Figure 10.

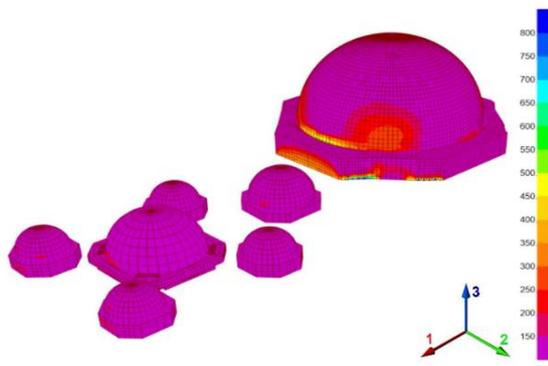
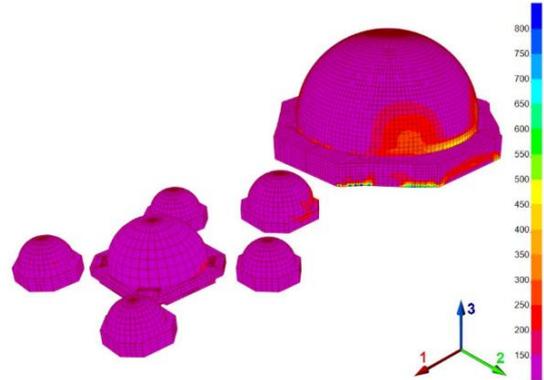
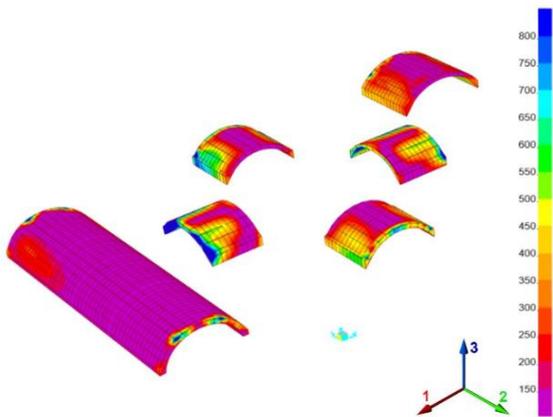
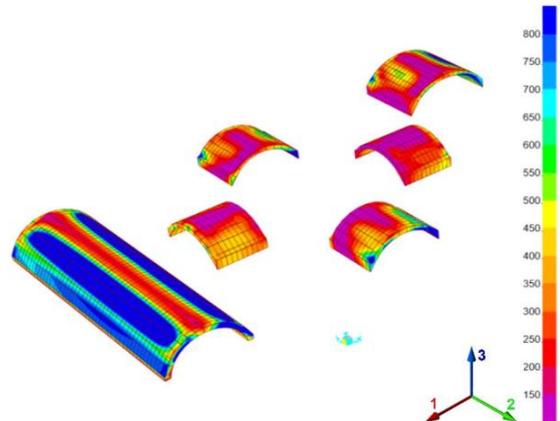
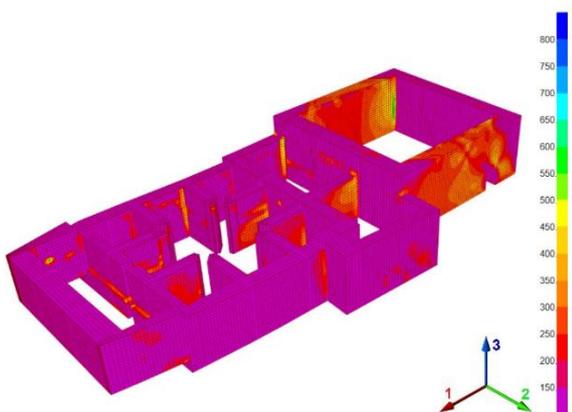
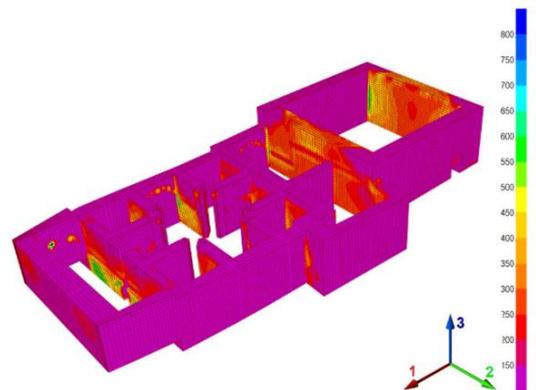
S13 -Domes

S23 -Domes

S13-Vaults

S23-Vaults

S13-Walls

S23-Walls

Figure 11. Shear stress distributions

The results of the analyses were evaluated separately for three different structural elements (dome, vault, and wall). Shear stress distributions due to the earthquake were analysed in two different components, 1-3 and 2-3. For each structural element, the stresses in two different directions were analysed and the maximum values determined on the whole element were noted. The elements where the shear strengths calculated by Equation No. 1 were exceeded were marked in red on Table 5. In the stress distributions given in Figure 11, the 1-3 component represents in-plane stresses for the elements extending in the 1 direction, while it represents out-of-plane behaviour for the elements extending in the 2-direction. The 2-3 component represents out-of-plane stresses for the elements extending in 1-direction and in-plane behaviour for the elements extending in 2-

directions. When Figure 11 and Table 5 are analysed, it is seen that the most damage due to the earthquake

occurred in the vaults, then in the internal walls and least in the domes and external walls.
