## The Analysis of Architectural Design Competitions within the Scope of Earthquake Resistant Design

### Abstract

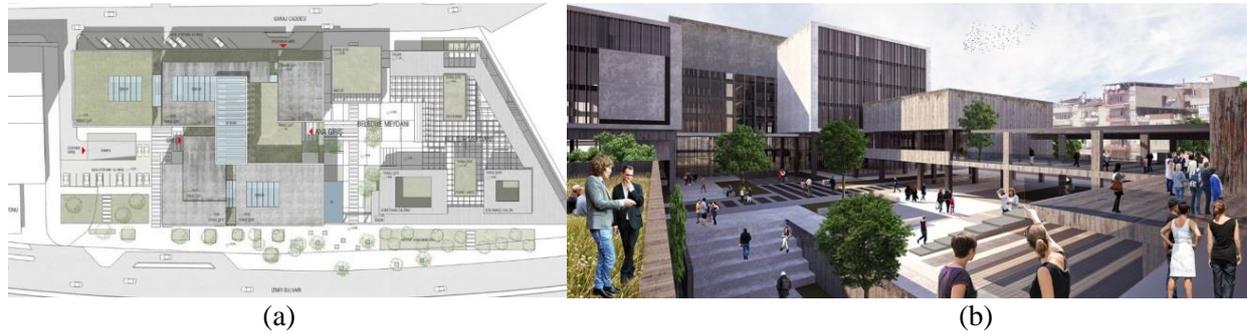
**Figure 3.1.** Efeler Town Hall (a) Situation plan, (b) Perspective view

In 2016, an architecture competition was organized for Efeler Town Hall located in the city center. Three different criteria were taken into account during the design process as an existing urban area, the effects of the building on its environment and the internal problems of the area. Apart from these main criteria, the urban green area in the project's site and in the city were considered insufficient. A suggestion was made for this problem in the ground floor solution of the designed building. An inner courtyard was built because the region is too hot during summer. Buildings were designed using small masses for a better harmony with their environment. Masses which comprise the town hall were placed in a lumped manner on the southern part of the land in order to cast a shadow on each other. Setbacks and eaves were built in order to create shady spots. Produced using reinforced concrete, the town hall includes numerous areas which require wide open spaces such as a conference hall, a multi-purpose hall and a chamber of

assembly. It was built on an area of 30800 square meters with 5 storeys and an indoor parking garage with a capacity of 285 cars on -1st and -2nd storeys [16] (Figure 3.1 a-b).

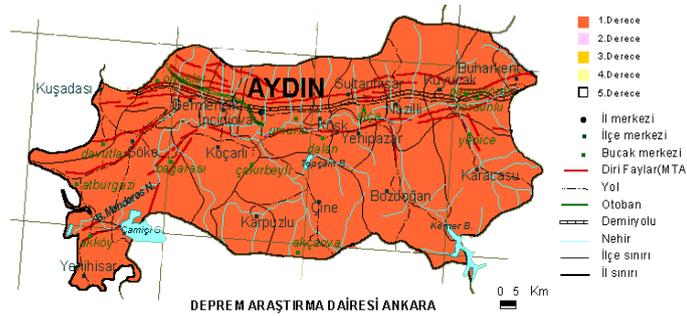
**Figure 3.2.** Aydın province earthquake map [17]

*Seismic Analysis of the Area:* Aydın province is located on a first-degree earthquake zone. In addition, Efeler where the town hall was built is also located on a first-degree earthquake zone [17] (Figure 3.2).

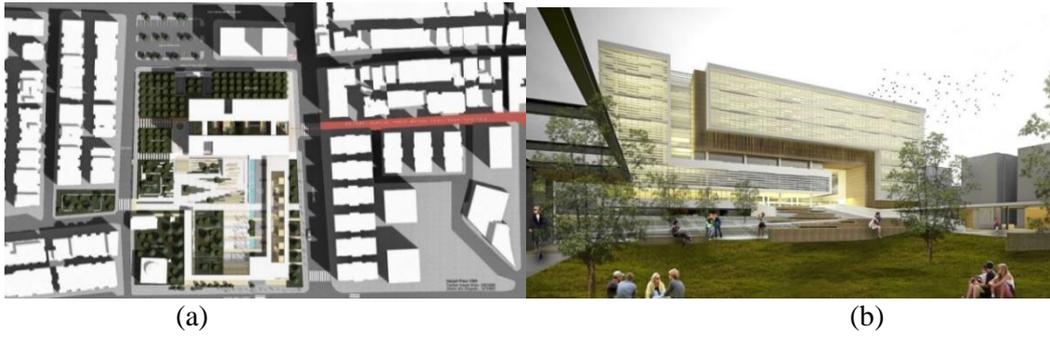
**Figure 4.1.** Efeler Town Hall (a) Situation plan, (b) Perspective view [16]

In 2015, an architecture competition was organized by Bornova Municipality. The design approach of the project was analyzed based on several criteria such as the connection between town hall and open public space, the scale of this open public space as a new square and its relationship with Bornova within the scope of its wide area, the potential of open public spaces as a recreation center and for night-time use, and the relationship of this open public space with surrounding streets. These streets were combined with a second ground floor created at +4.50 elevation. An intermediary space was planned for upper storeys of the town hall, and the structure was divided into two parts from one end to the other. These divided masses were connected to each other through steel bridges with a green roof. Thus, it was aimed to save energy during the climatization of this intermediate space instead of building a 7-storey gallery. The project consists of a town hall of 20000 square meters, a parking garage of 15000 square meters, an open public space of 17500 square meters, and it has 5 basements, a ground storey and 7 storeys [18] (Figure 4.1 a-b).

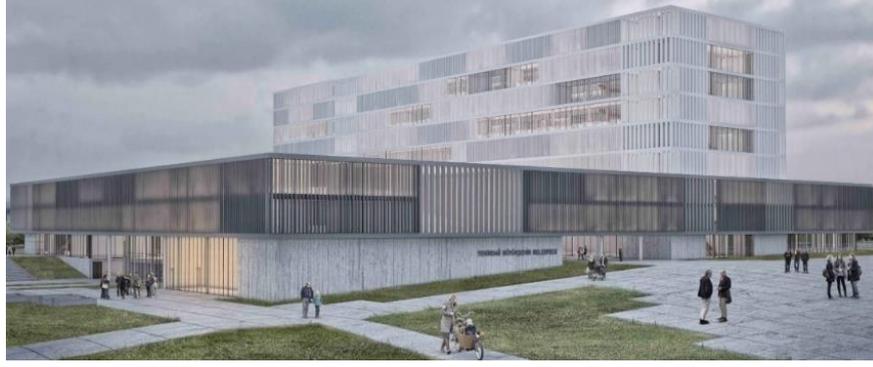
**Figure 5.1.** Tekirdağ City Hall view [21]

In 2016, an architecture competition was organized in Tekirdağ, and the project land is located in Süleymanpaşa district. The city hall is not a structure that completely sits on the ground, but it is shaped by leaving the ground completely to the urbanite. It contributes to urban green areas, sustainability of building, and was designed with an attitude questioning classical town halls. This complex is considered as the center of urban life. Therefore, it was designed as a public space which turns its spatial limits into an advantage, allows citizens to naturally experience urban life, encourages and benefits from citizens' participation instead of being a town hall which is only frequented by citizens for official business. Moreover, it is far from being an inaccessible urban area outside working hours and is not isolated from the city and its citizens. Streets surrounding the area and green axes designed within the scope of urban decision-making process were maintained in the land, and enabled the town hall to be integrated into the structural integrity of the city. The project consists of 2 basements and ground storey and 8 storeys, and has an area of 68.825 square meters [21;22] (Figure 5.1).

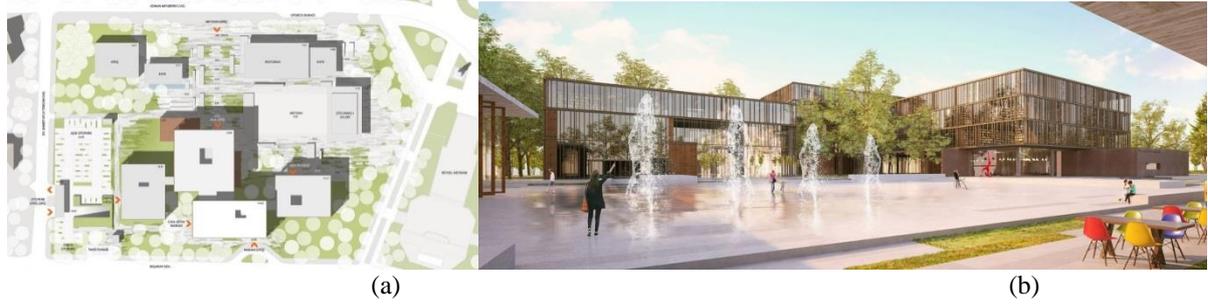
**Figure 6.1.** İnegöl Town Hall (a) Situation plan, (b) Perspective view

In 2016, an architecture competition was organized by İnegöl Municipality for a project located on a land surrounded by a green area. Therefore, the project design mainly aimed to avoid ruining this green area and turn it into an effective center for public use. The ground floor of the town hall was planned by taking a landscape area which allows citizens to freely move into account. In addition, alternative spaces in this landscape area were designed as leisure time spaces where citizens can sit and rest even when they do not have any official business in the town hall. Four different buildings are located among trees and connected to each other through bridges. All storeys in the area are connected to each other through ramps, which allow the circulation in the public space to continue. The project has an area of 19369 square meters and consists of 2 basements, a ground storey and 4 upper storeys [24] (Figure 6.1 a-b)

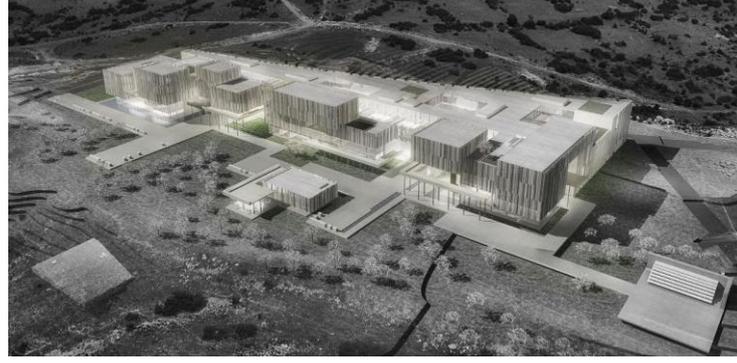
**Figure 7.1.** Balıkesir City Hall view [26]

In 2016, an architecture competition was organized by Balıkesir Metropolitan Municipality for a town hall building, and the winning project is located on a land in east-west direction in order to interact with its land and surrounding environment as much as possible. The structure faces the urban park located in its southern part, and approaches this park as a public square. The formation of a moving mass on the southern facade of the structure can be attributed to the objective of integrating the mass into urban view and benefiting from physical properties of the southern facade. The placement decisions were made in order to increase this structural permeability. The atrium which connects northern and southern masses also connects program functions and transfers structural permeability to upper storeys. The structure consists of 2 basements, a ground storey and 4 upper storeys [26] (Figure 7.1).
